ANNUAL REPORT FOR 2000

**Long Creek Mitigation Site
Mecklenburg County
Project No. 8.U672204
TIP No. R-2248**

Prepared By:
Natural Systems Unit & Roadside Environmental Unit
North Carolina Department of Transportation
December 2000

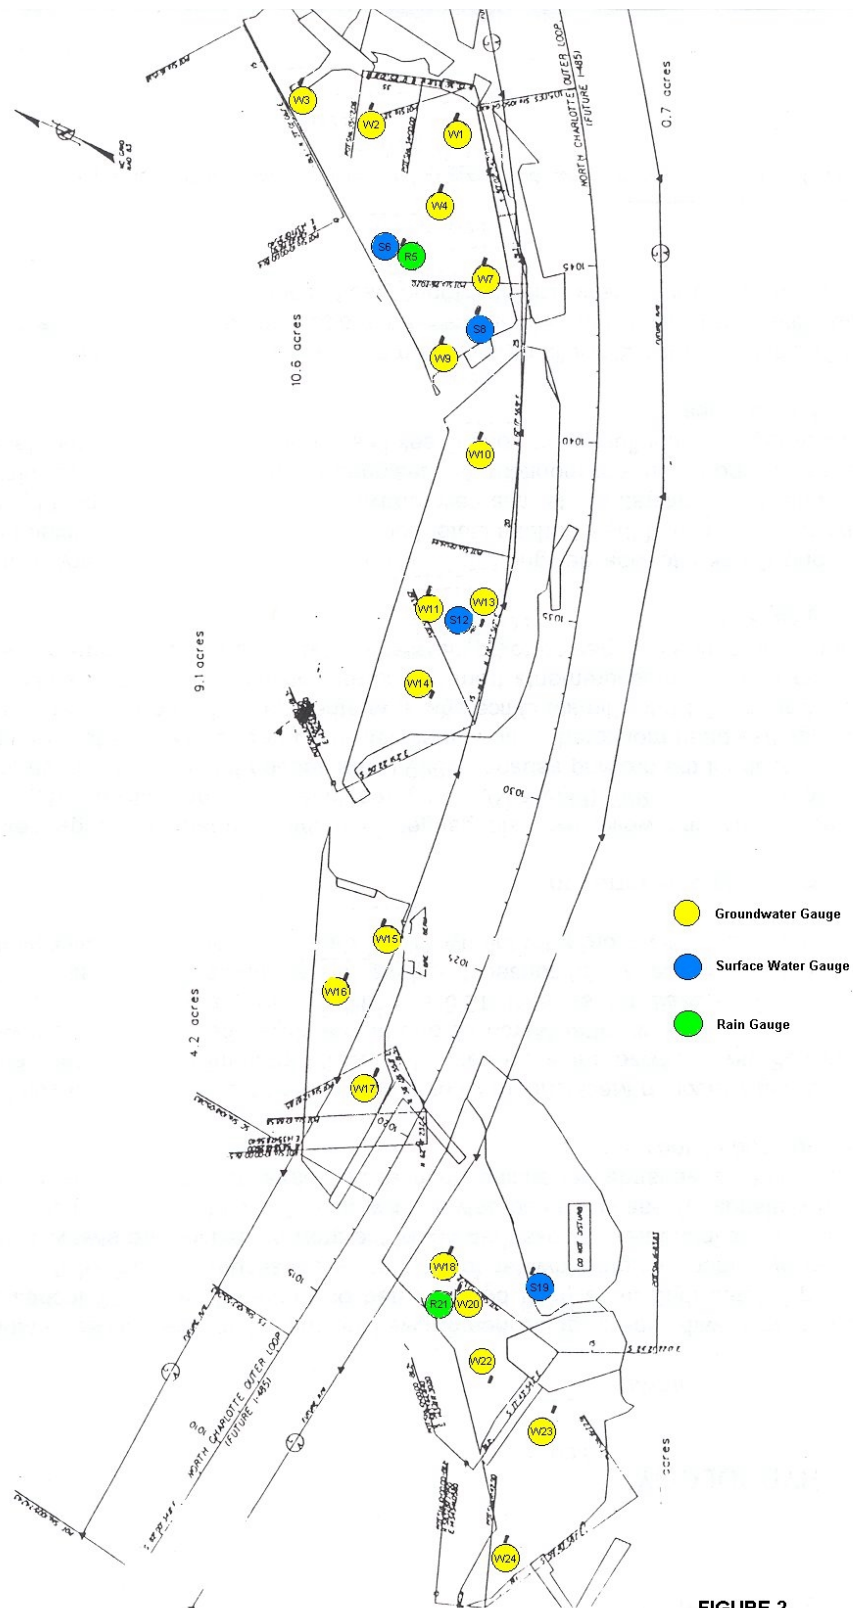
**FIGURE 2
GAUGE LOCATION MAP**

Eighteen groundwater gauges, two rain gauges, and three surface water gauges were installed in October 1997 (Figure 2). Daily readings of the groundwater depth were taken throughout the growing season. 2000 is the third full growing season that the hydrology has been monitored. The rainfall data used to analyze the site groundwater data is from partially from the NC State Climate Office official weather station located in Charlotte and partially from the on-site rainfall gauges.

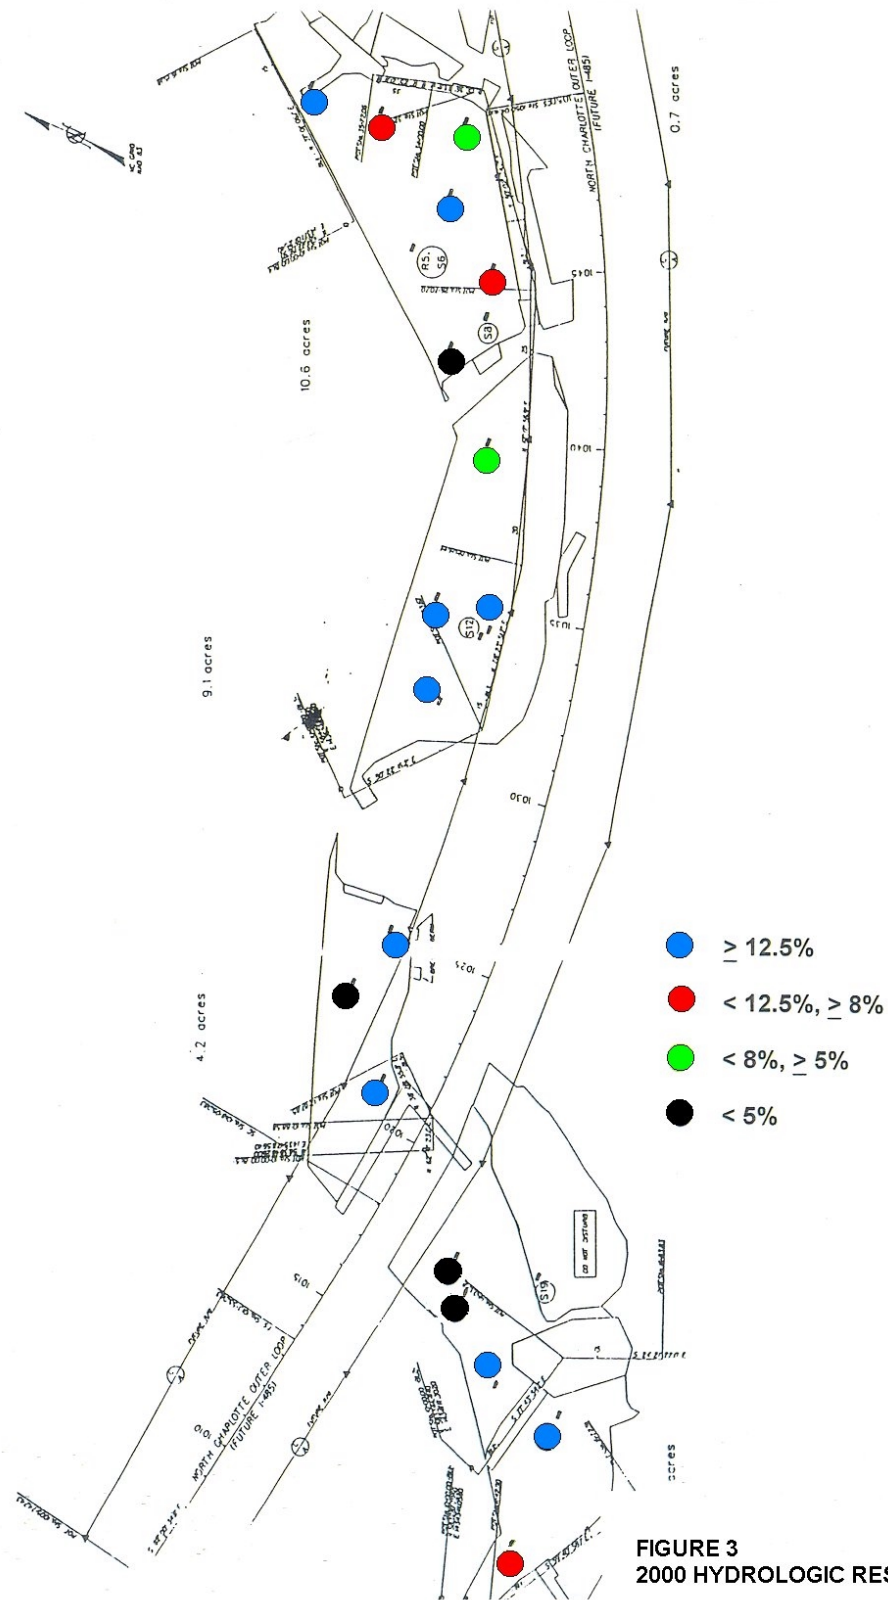
FIGURE 3
2000 HYDROLOGIC RESULTS

The placement of the groundwater gauges and a graphical representation of the hydrologic monitoring results are provided in Figure 3.

In 1998, thirteen of the eighteen groundwater gauges met the hydrologic success criteria. One year later, none of the gauges indicated saturation for more than 12.5% of the growing season. However, in 2000 nine of eighteen met the hydrologic success criteria. More importantly, trends are beginning to emerge that indicate which climatic conditions are necessary for success and which areas of the site are meeting the success criteria and which areas are not. DOT will continue monitoring the site and the development of these trends.

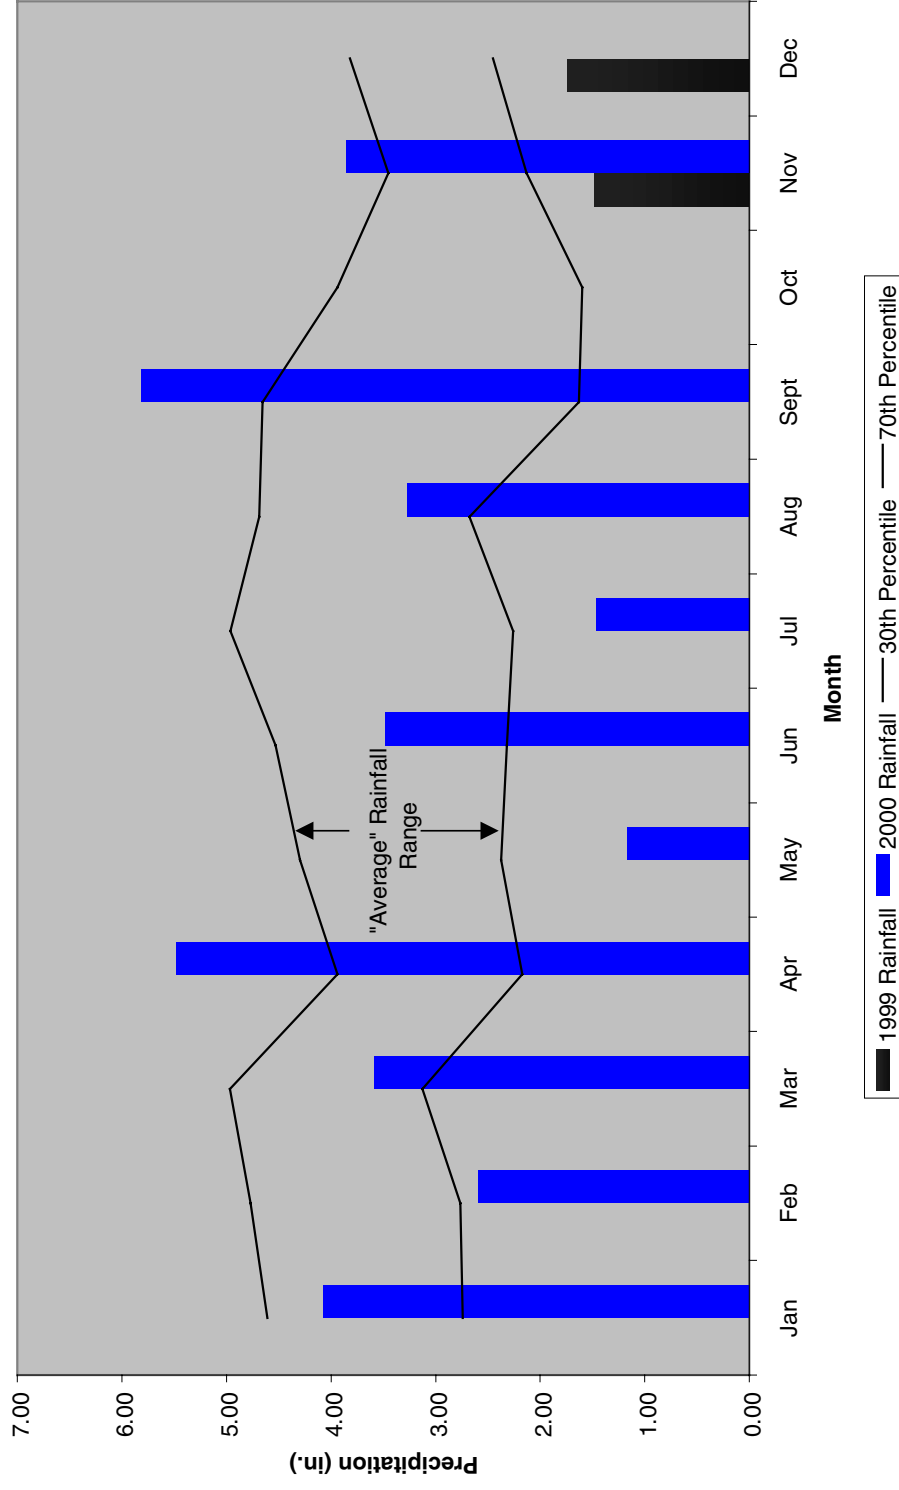
Figure 4.
Long Creek 30-70 Percentile Graph
Charlotte, NC

Figure 4 is a comparison of 2000 monthly rainfall to historical precipitation for the Charlotte area. Rainfall data was recorded by averaging the measurements of the two rain gauges at the site. Rainfall data from the Charlotte weather station was substituted from March 22 through April 28, before the rain gauges were installed, and from August 7 through September 6, when the gauges failed. The rainfall amounts were compared to the historical 30-70 percentile trends for the area. It is assumed that if the 2000 rainfall totals, represented by bars, fall between the average precipitation values for each month, then the local climate was experiencing average conditions for that particular region.

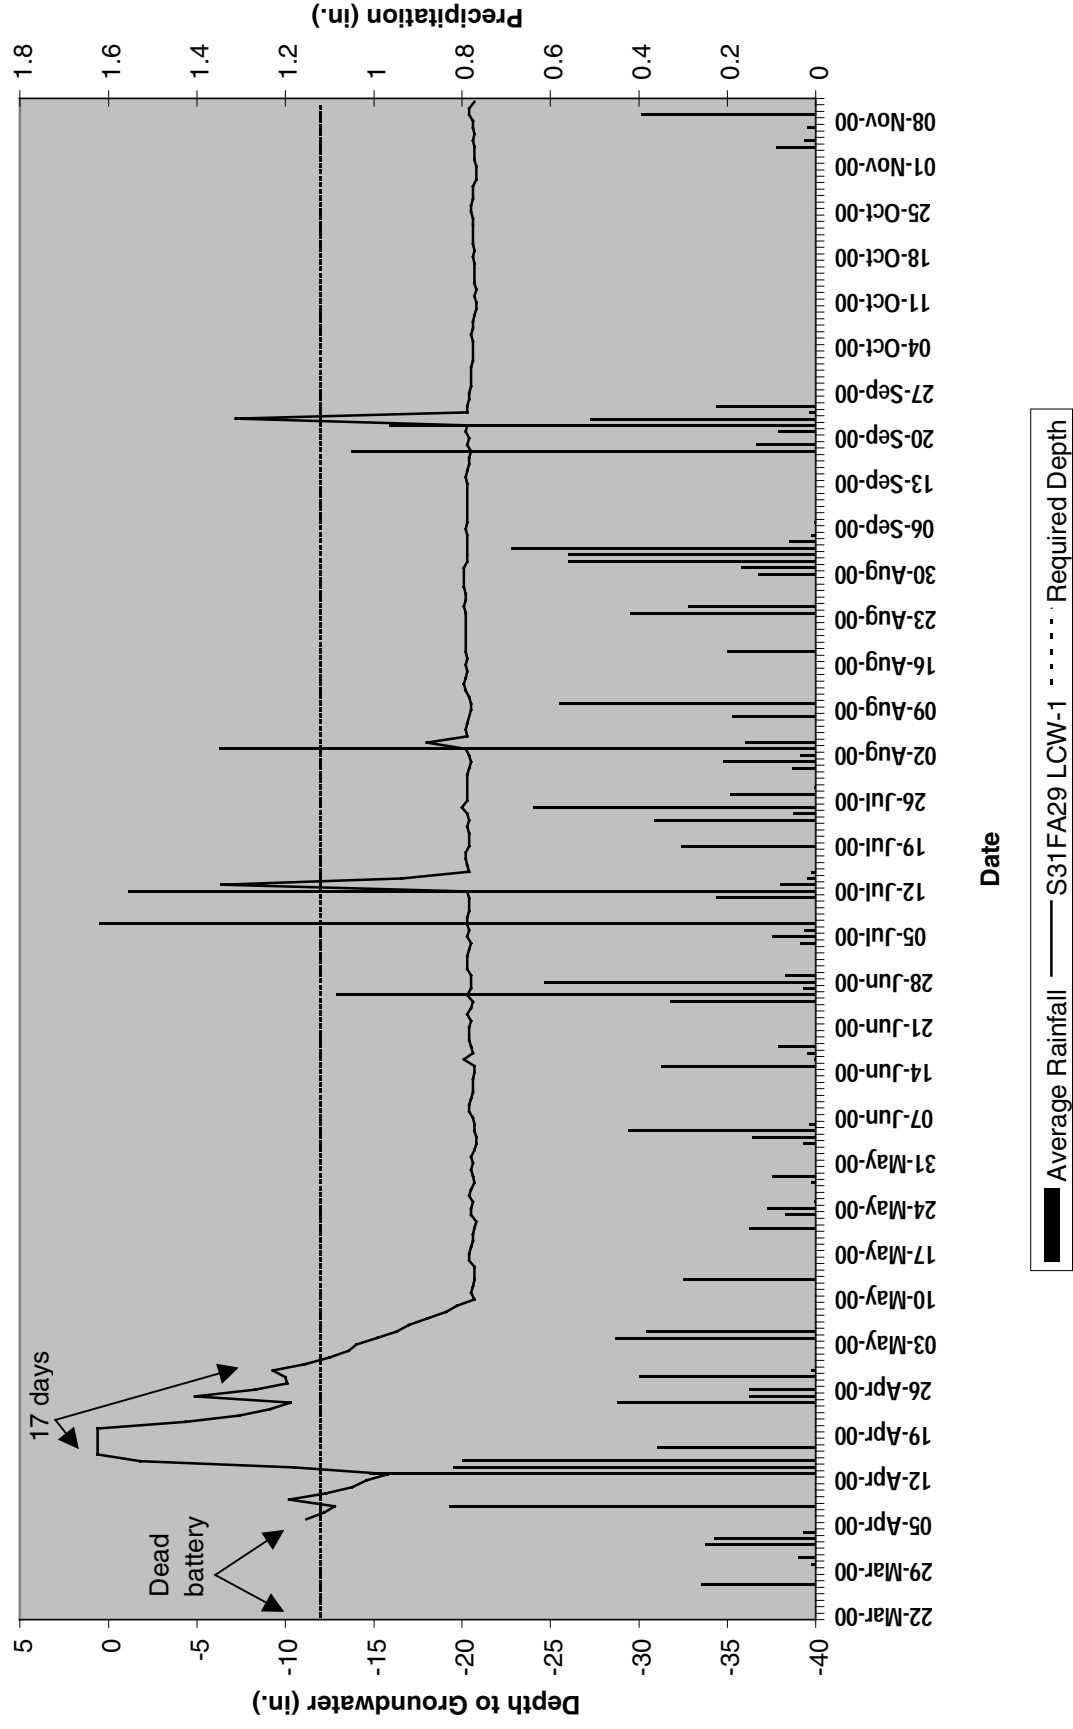
Long Creek LCW-1

| Monitoring Well | < 5% | 5% - 8% | 8% - 12.5% | > 12.5% | Actual % | Dates of Success |
|---|---|---|---|---|---|---|
| LCW-1 | | ✓ | | | 7.2 | Apr 14- Apr. 30 |

Specific monitoring well problems: A number of data sets were lost due to dead batteries, specifically groundwater gauges 1, 2, 16, 18, 20, and 24. These are noted on the graphs in Appendix A.

However, relying on the supposition that the critical period of monitoring is the beginning of the growing season, only gauges 1 and 24 had their hydrologic success effected, since the lost data was the first 17 days of the growing season. For gauge 24, based on past performance and the surrounding wells, it is reasonable to assume that the first 17 days would have indicated groundwater within 12 inches of the ground surface. Based on this assumption, gauge 24 would have met the 12.5% success criteria. The inferences one can draw on gauge 1 are not as defined, but may become so with continued monitoring.

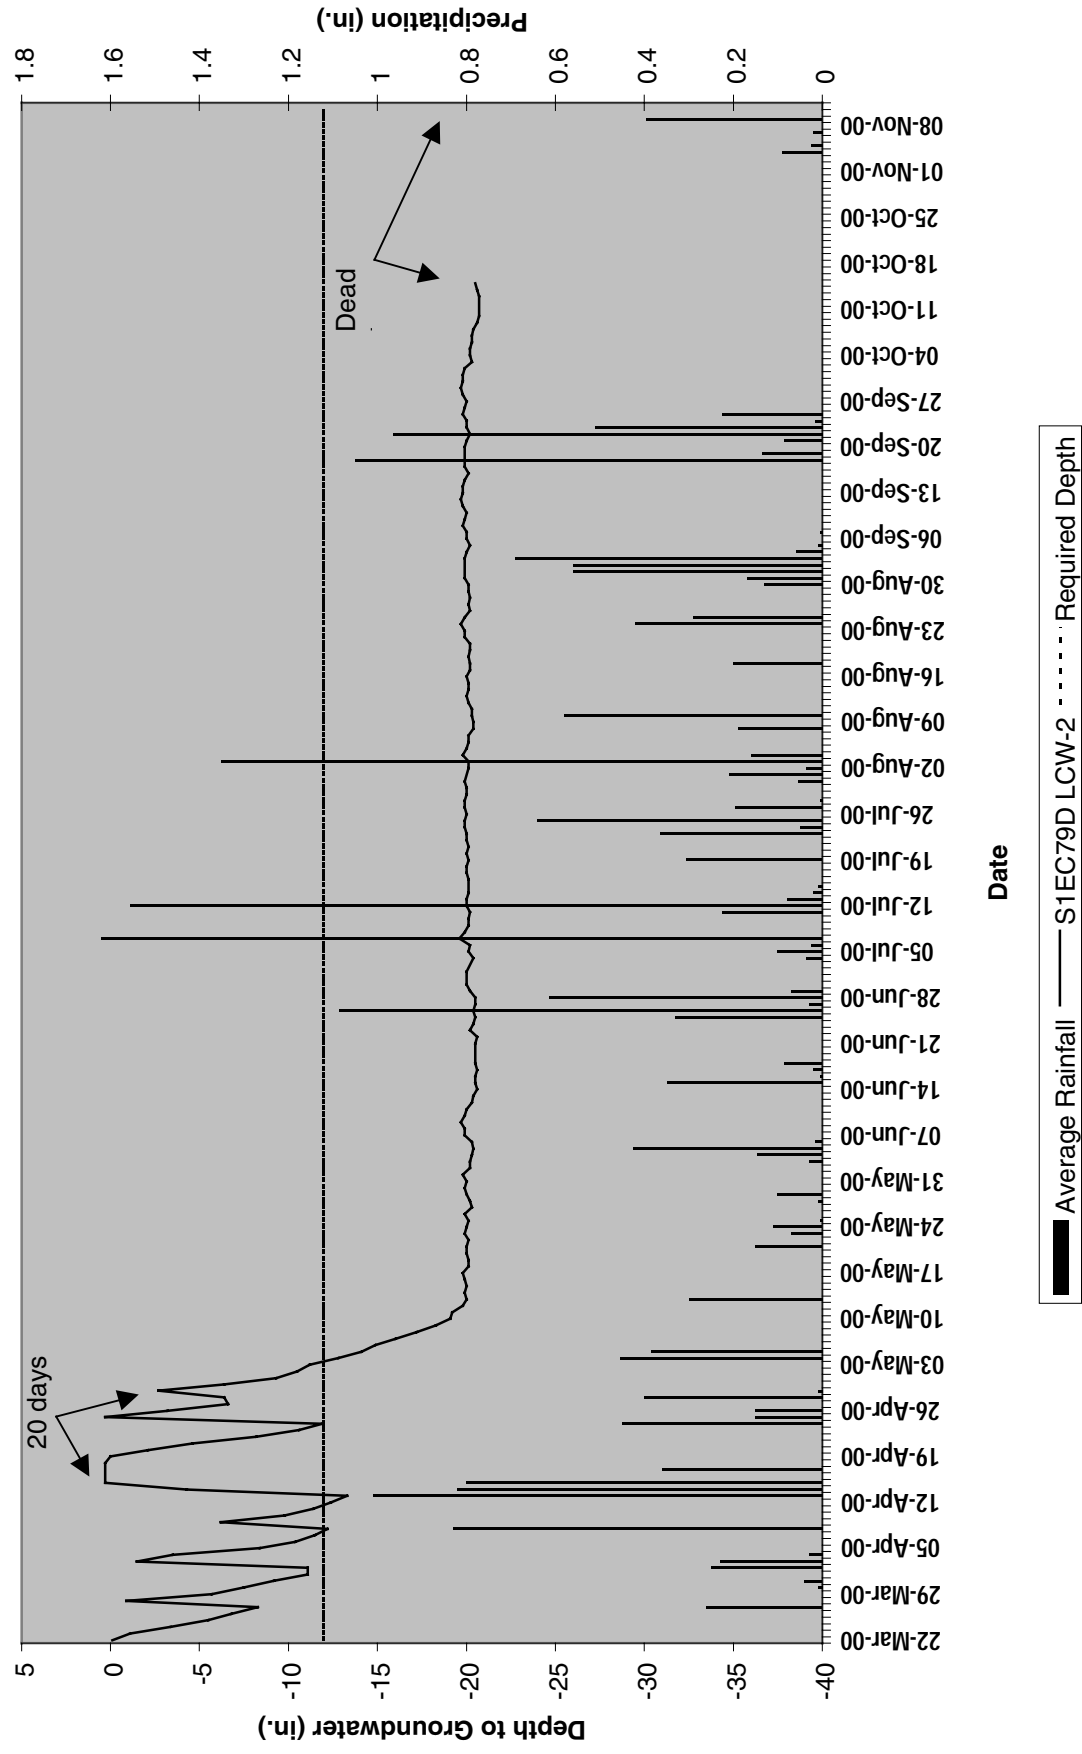
Long Creek LCW-2

| Monitoring Well | < 5% | 5% - 8% | 8% - 12.5% | > 12.5% | Actual % | Dates of Success |
|---|---|---|---|---|---|---|
| LCW-2 | | | ✓ | | 8.5 | Apr 14- May 3 |

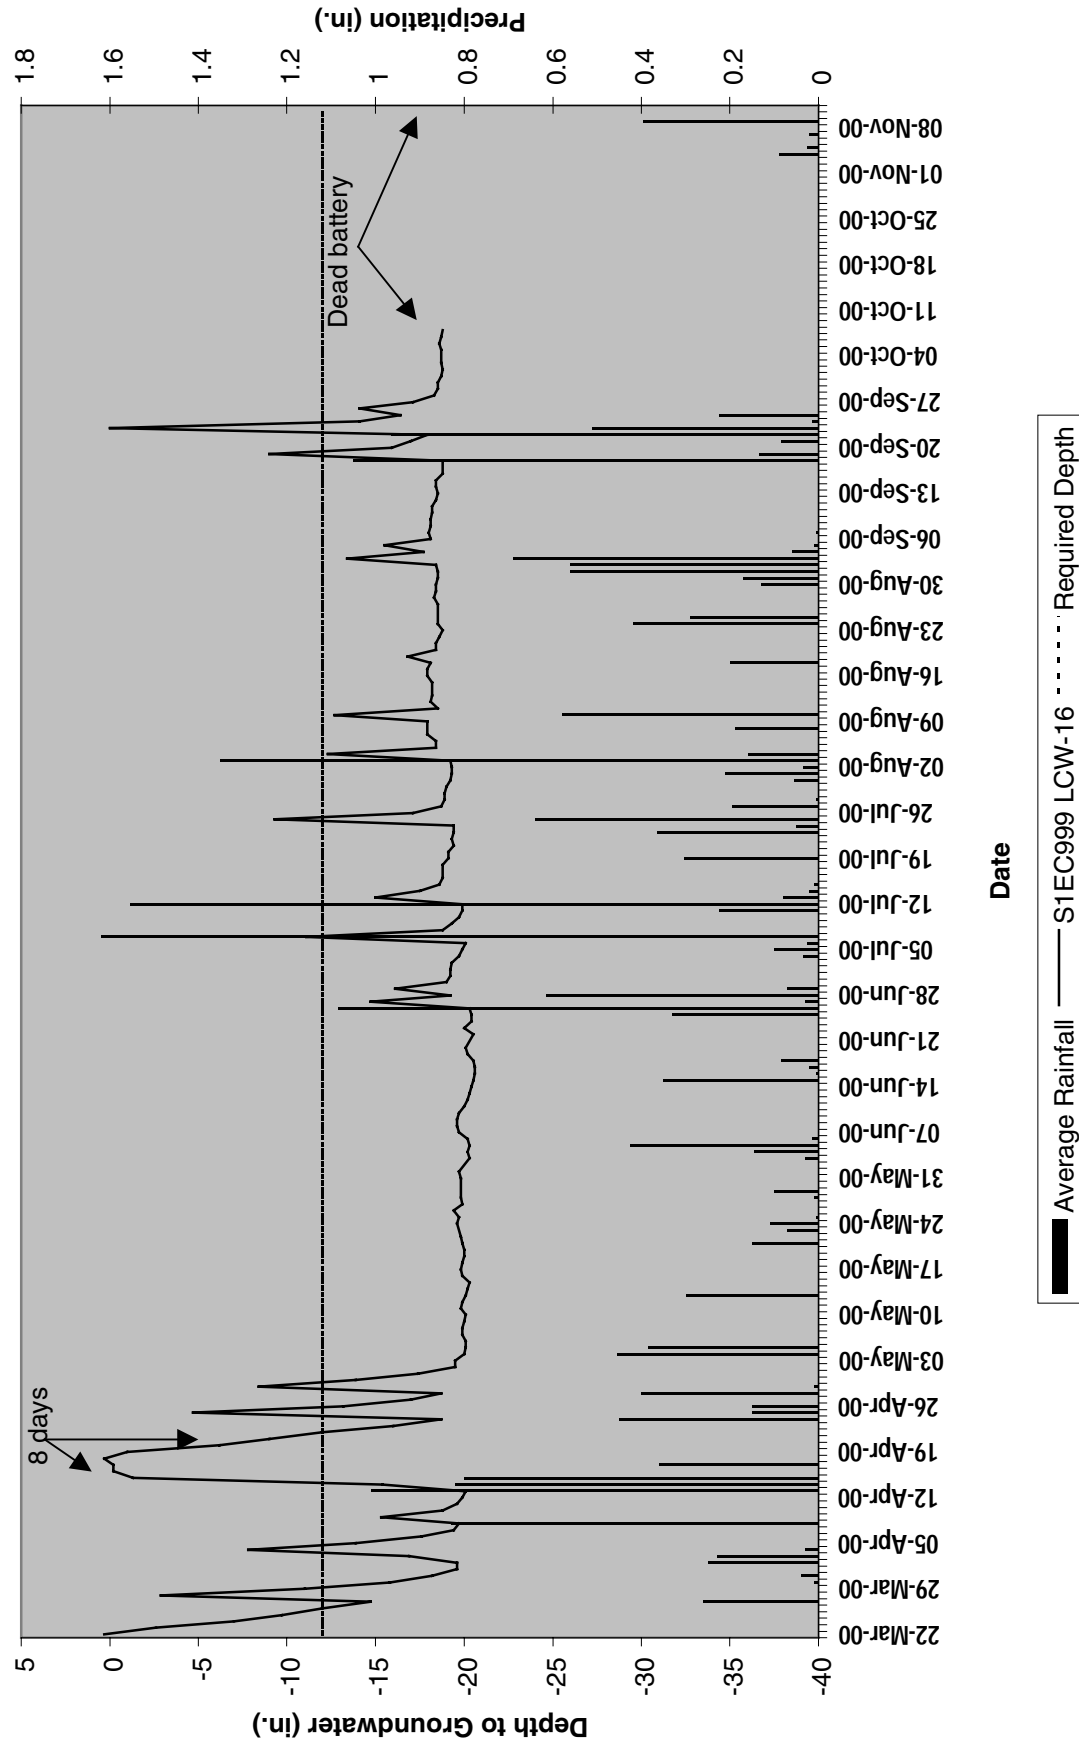
Long Creek LCW-16

| Monitoring Well | < 5% | 5% - 8% | 8% - 12.5% | > 12.5% | Actual % | Dates of Success |
|---|---|---|---|---|---|---|
| LCW-16 | ✓ | | | | 3.4 | Apr 15- Apr 22 |

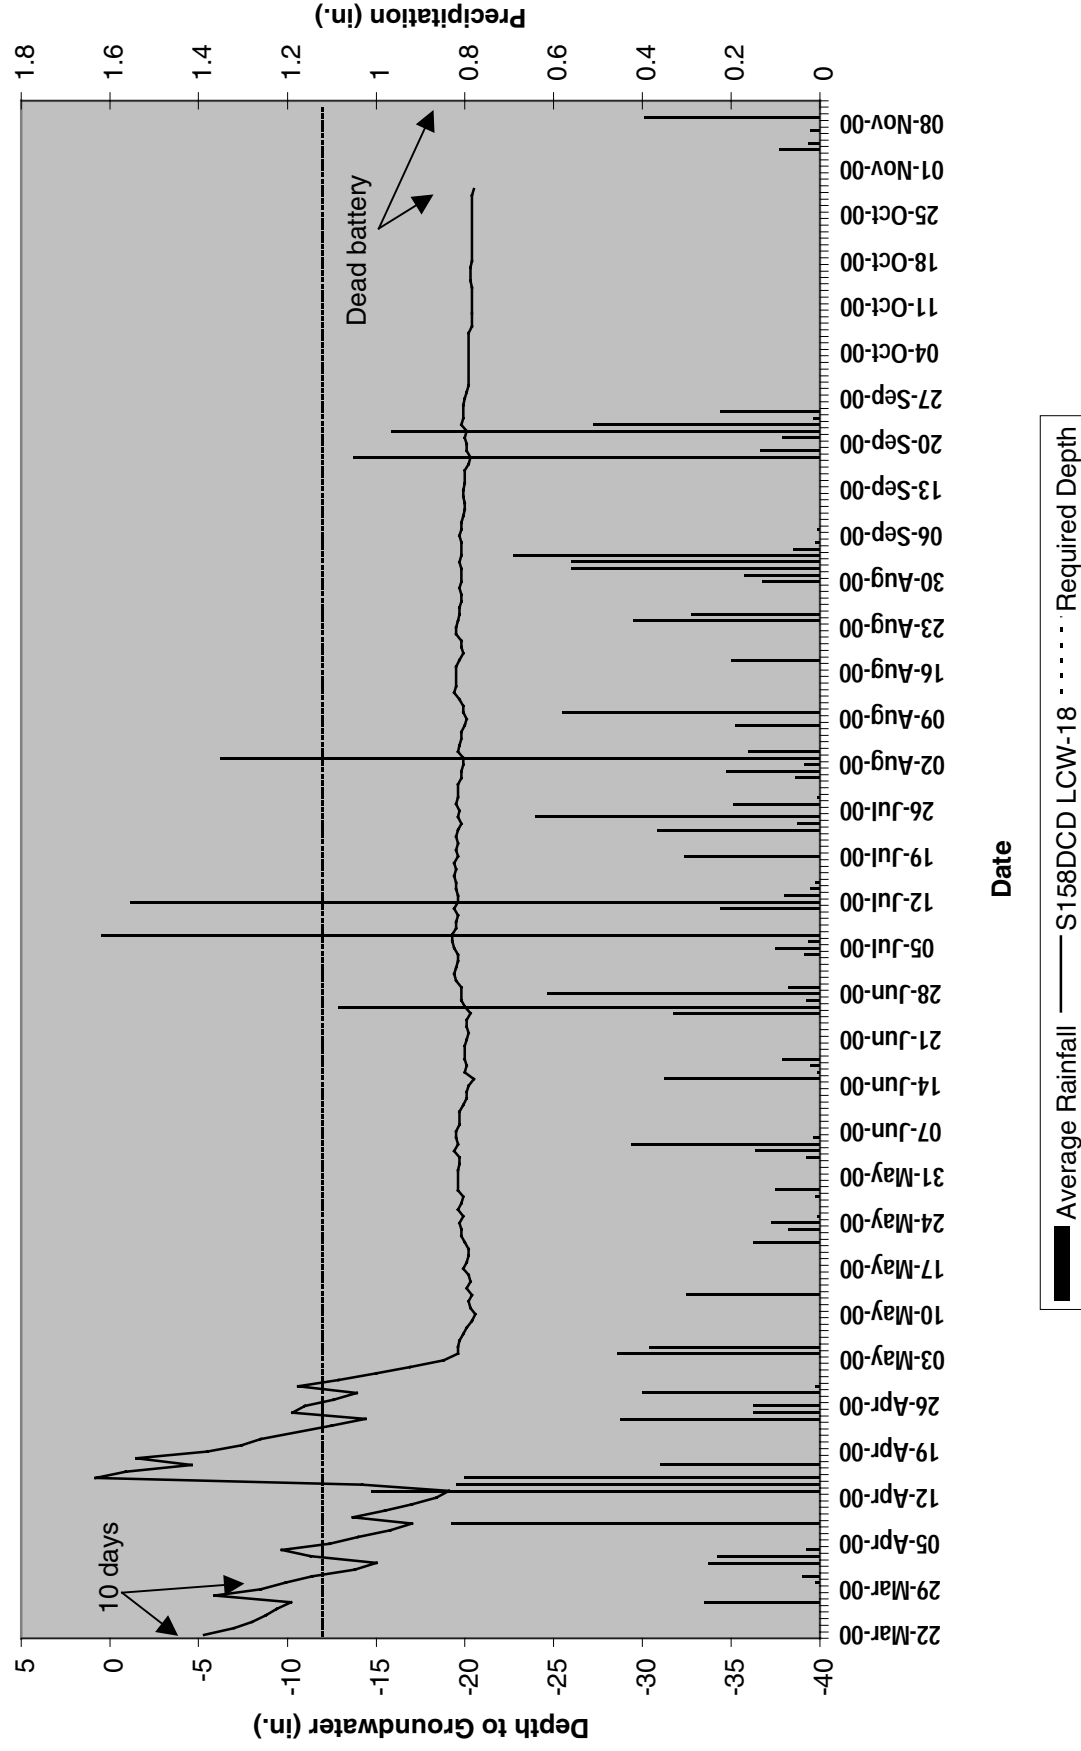
Long Creek LCW-18

| Monitoring Well | < 5% | 5% - 8% | 8% - 12.5% | > 12.5% | Actual % | Dates of Success |
|---|---|---|---|---|---|---|
| LCW-18 | ✓ | | | | 4.3 | Mar 22- Mar 31 |

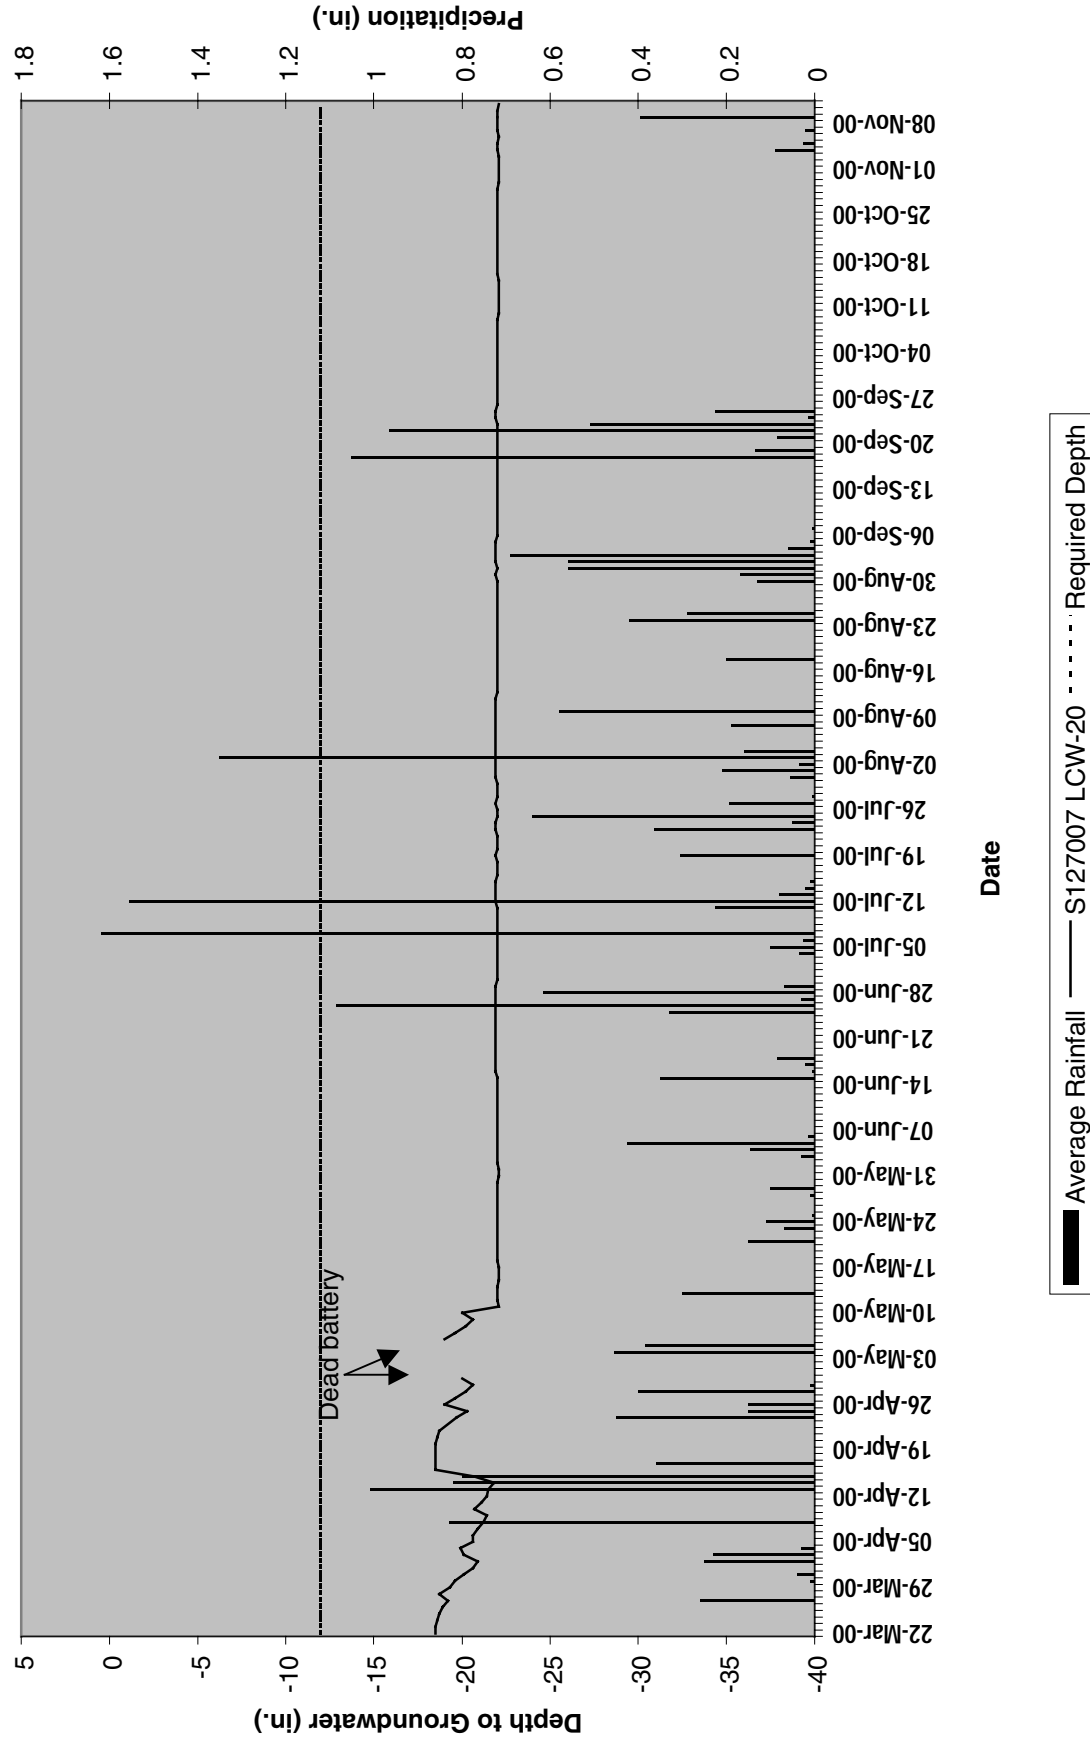
Long Creek LCW-20

| Monitoring Well | < 5% | 5% - 8% | 8% - 12.5% | > 12.5% | Actual % | Dates of Success |
|---|---|---|---|---|---|---|
| LCW-20 | ✓ | | | | 0.0 | |

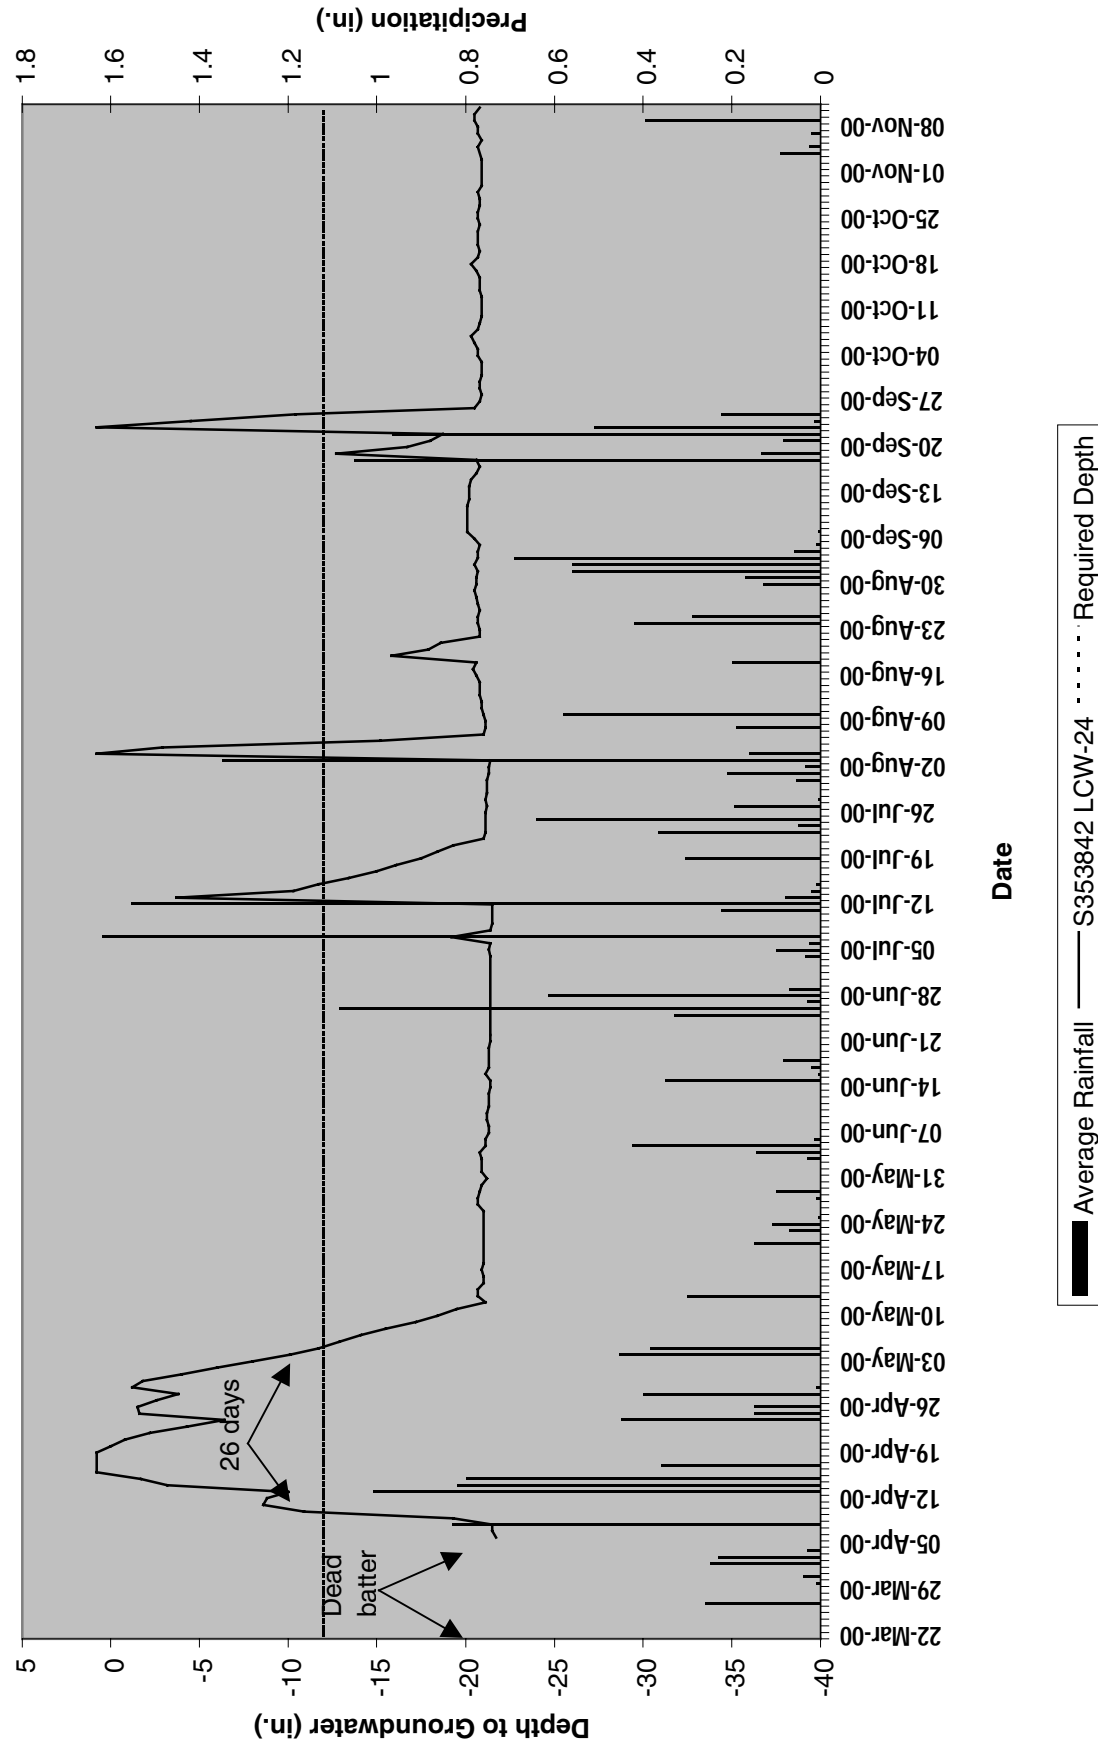
Long Creek LCW-24

| Monitoring Well | < 5% | 5% - 8% | 8% - 12.5% | > 12.5% | Actual % | Dates of Success |
|---|---|---|---|---|---|---|
| LCW-24 | | | ✓ | | 11.1 | Apr 10- May 5 |
